Contract #: 04-0120F4Cty: SF/ALA Rte: 80 PM: 13.2/13.9File #: 1.28**WELDING INSPECTION REPORT****Resident Engineer:** Casey, William**Address:** 333 Burma Road**City:** Oakland, CA 94607**Report No:** WIR-027800**Date Inspected:** 19-Jun-2012**Project Name:** SAS Superstructure**OSM Arrival Time:** 700**Prime Contractor:** American Bridge/Fluor Enterprises, a JV**OSM Departure Time:** 1730**Contractor:** American Bridge/Fluor Enterprises, a JV**Location:** jobsite**CWI Name:** Steve Jensen**CWI Present:** Yes No**Inspected CWI report:** Yes No N/A**Rod Oven in Use:** Yes No N/A**Electrode to specification:** Yes No N/A**Weld Procedures Followed:** Yes No N/A**Qualified Welders:** Yes No N/A**Verified Joint Fit-up:** Yes No N/A**Approved Drawings:** Yes No N/A**Approved WPS:** Yes No N/A**Delayed / Cancelled:** Yes No N/A**Bridge No:** 34-0006**Component:** OBG**Summary of Items Observed:**

WELDING INSPECTION REPORT

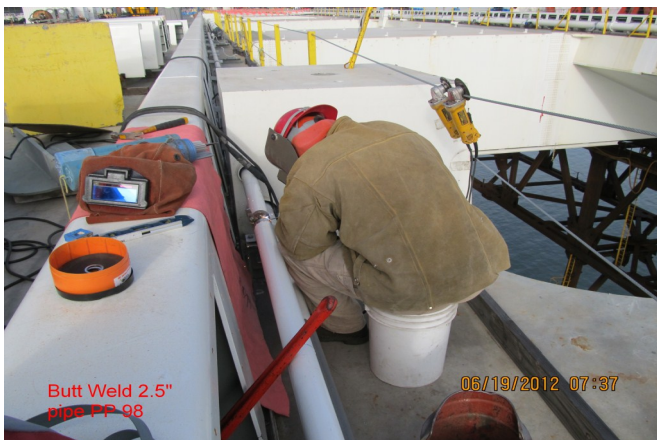
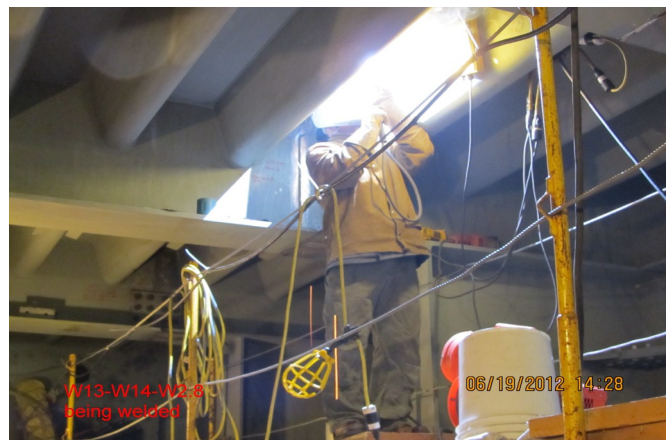
This QAI observed the preheating of deck splice 13W-14W-W2.8. The QC recorded and QAI verified preheat was being accomplished by utilization of an induction heating blanket. A constant preheat of 250F was randomly verified by this QAI throughout the shift.

QAI observed the back welding of deck splice 13W-14W-W2.8 by welder Jeremy Doleman in the 4G position utilizing the Shield Metal Arc Welding (SMAW) Process. E7018 consumable electrode was being used to the QC recorded QAI randomly verified parameters of Welding Procedure Specification ABF-WPS-D15-1040C-CV. The welder was using a stringer technique to fill in the back-gouge. A power wire brush and manual chipping hammer was being used to clean between passes.
